Debris/Ice/TPS Assessment And Photographic Analysis For Shuttle Mission STS-31R

June 1990

Charles G. Stevenson
NASA/Kennedy Space Center

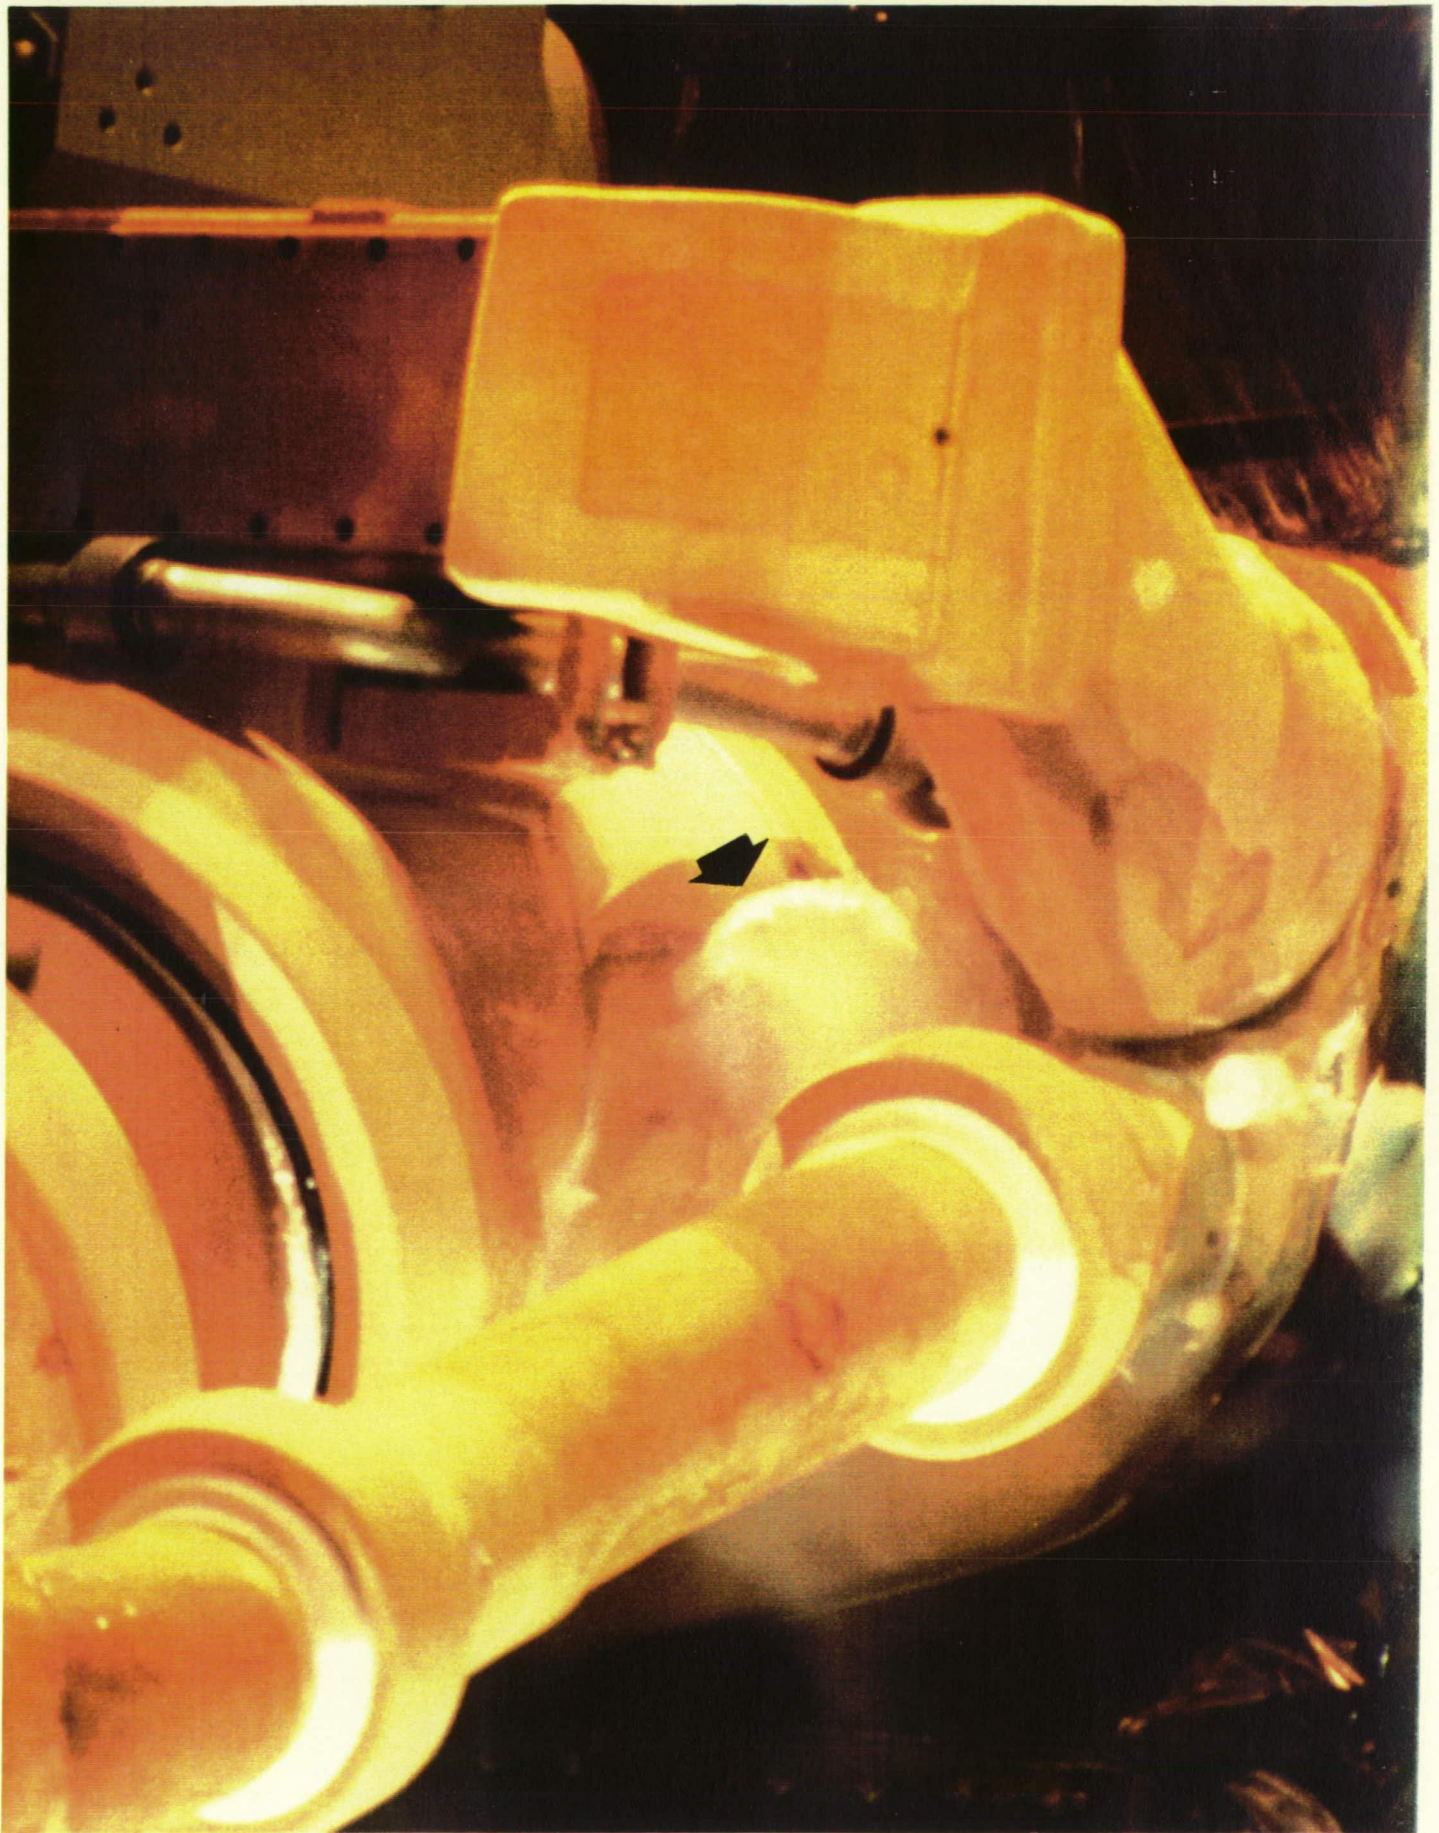
An LCC waiver was granted for the 10"x10"x1" ice/frost covering the flapper valve actuator port PDL plug closeout

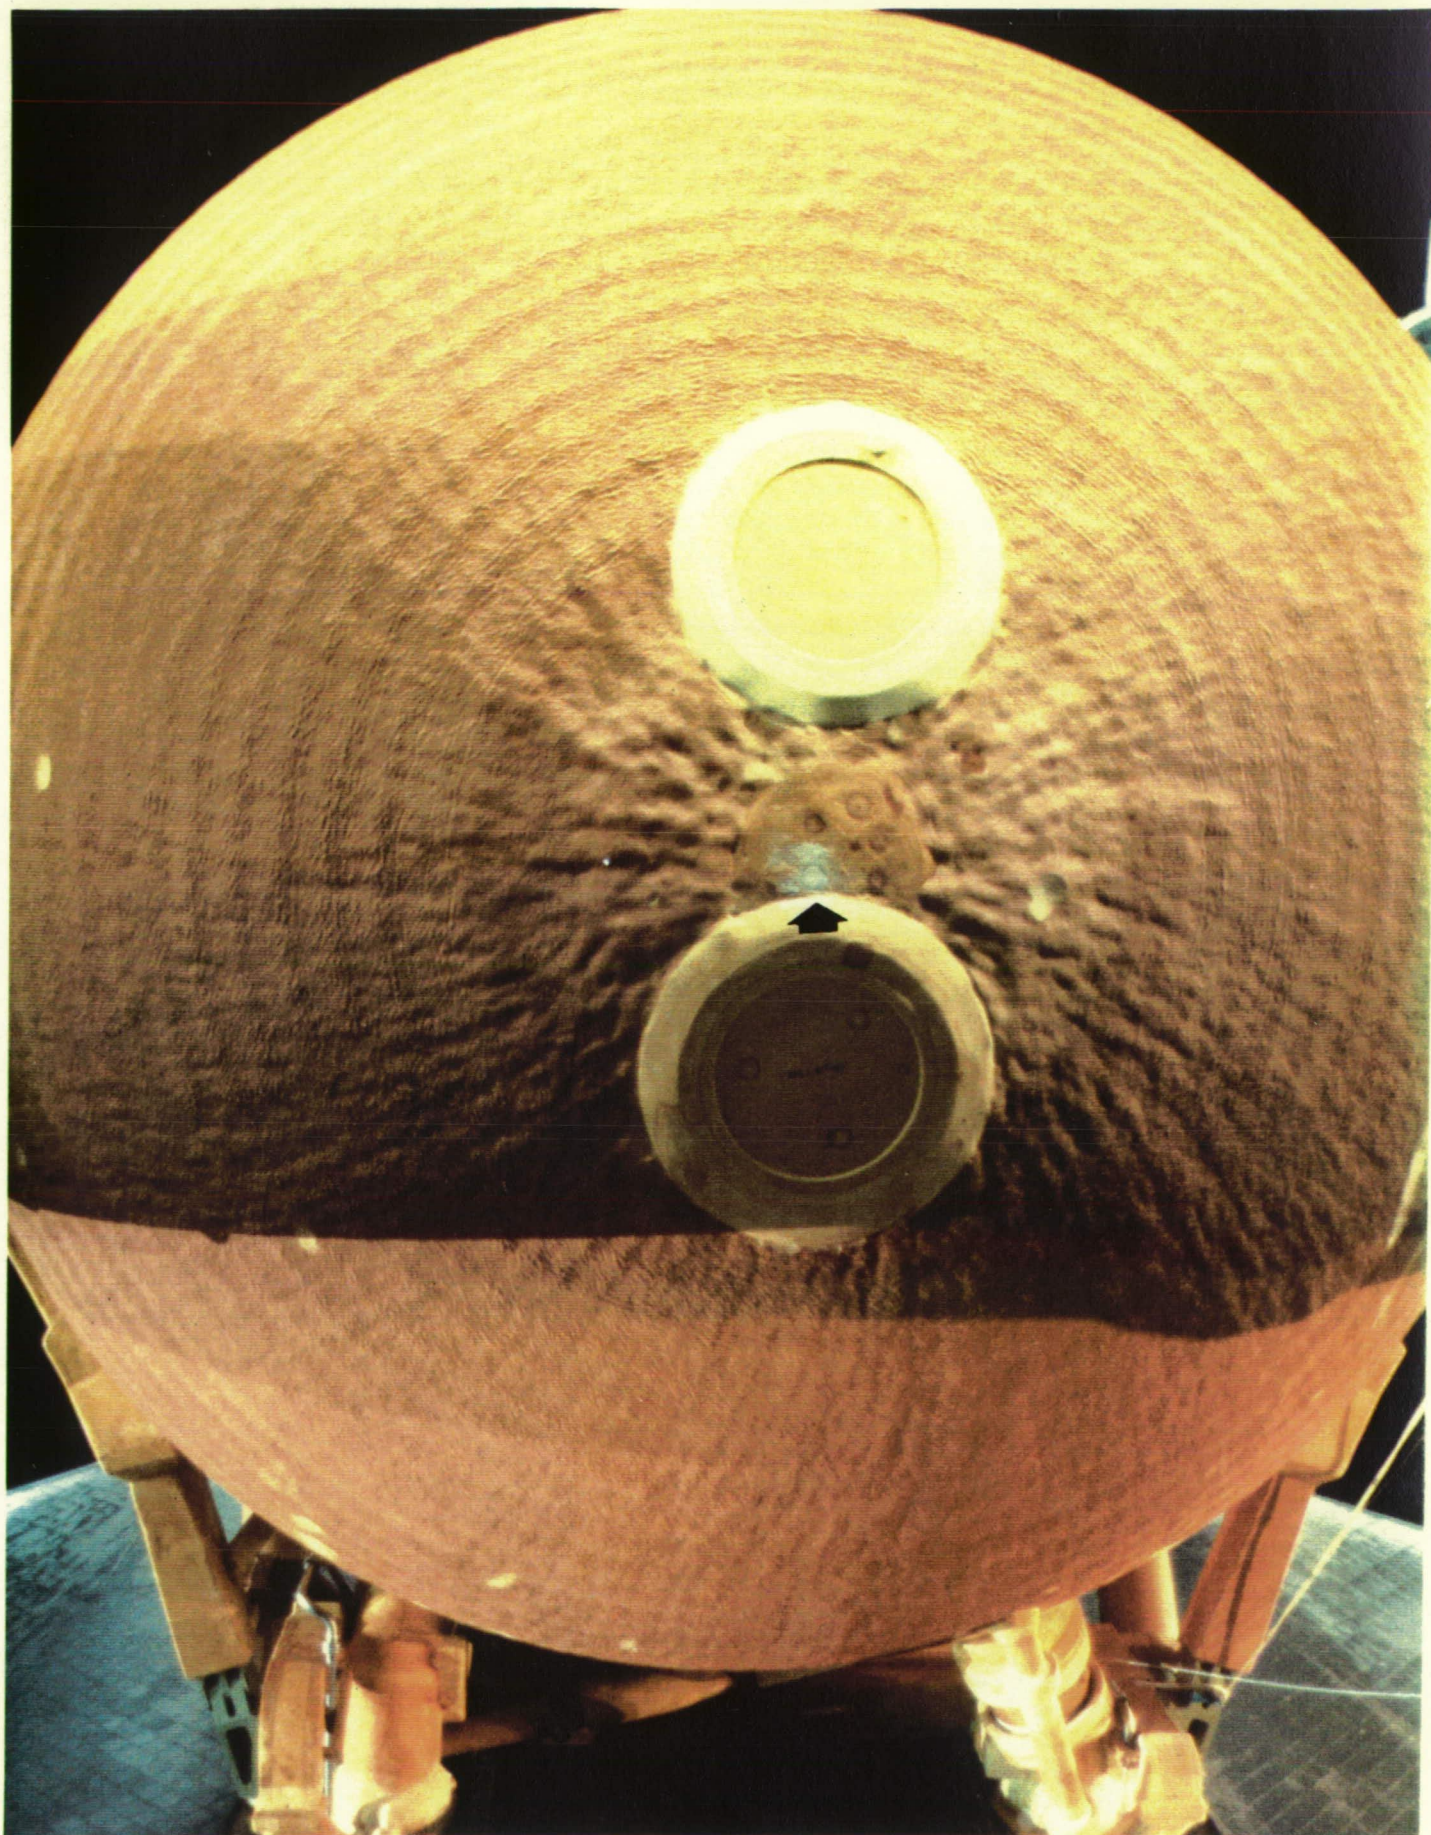
No TPS defects or anomalies occurred on the ET aft dome. No frost formed on the 3-inch diameter apex repair.

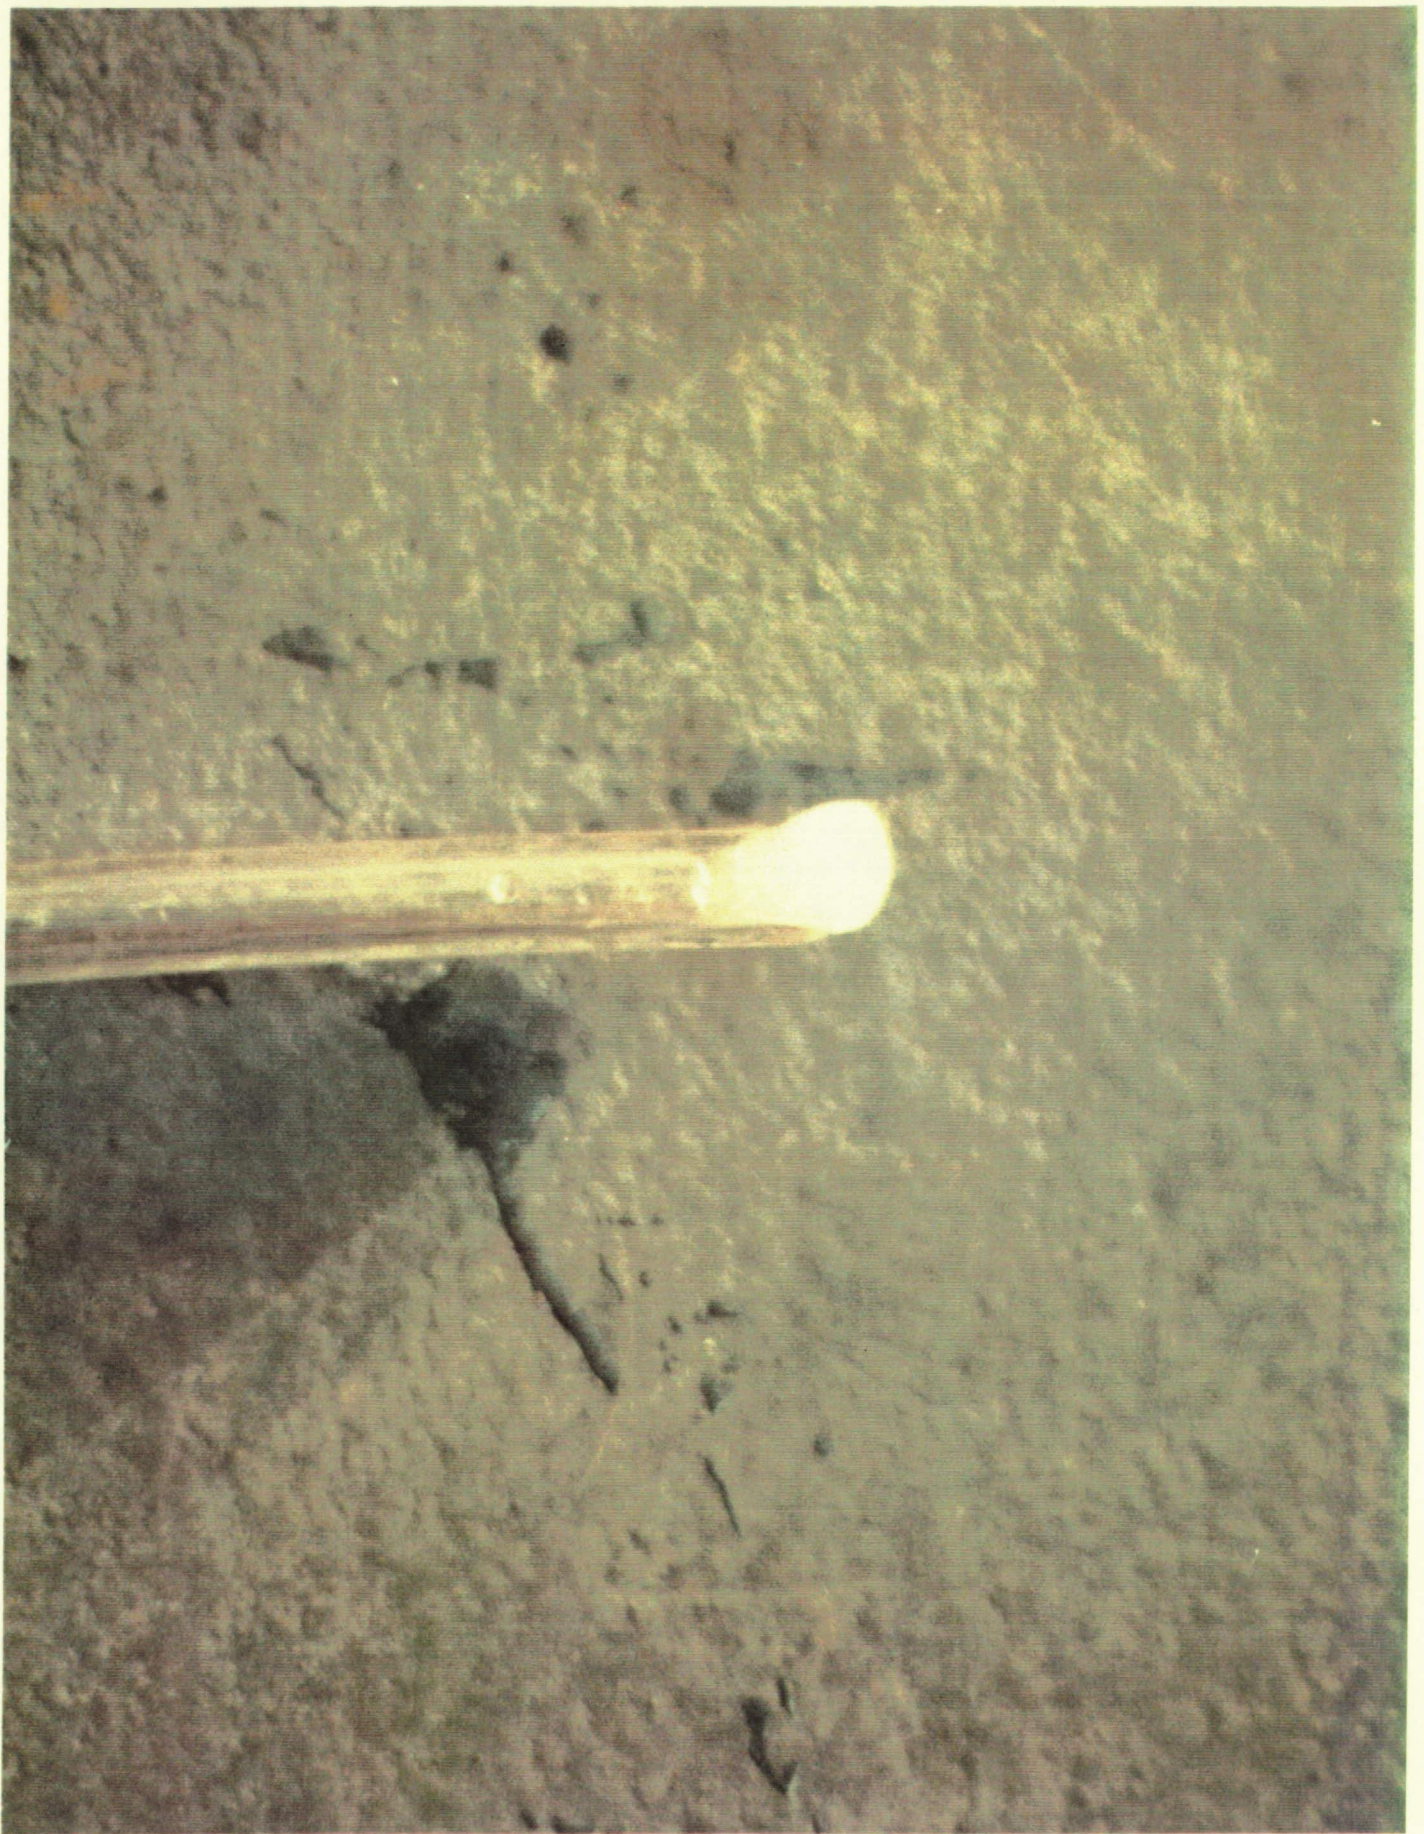
The ET/ORB hydrogen detection sensor tygon tubing was removed with no damage to the vehicle. However, the outboard tube had drooped close enough to the umbilical for ice to form around and in the end of the tube to a depth of 1-1/2 inches.

The hydrogen detection system tygon tubing drooped and became plugged when ice formed on top of the LH2 ET/ORB umbilical

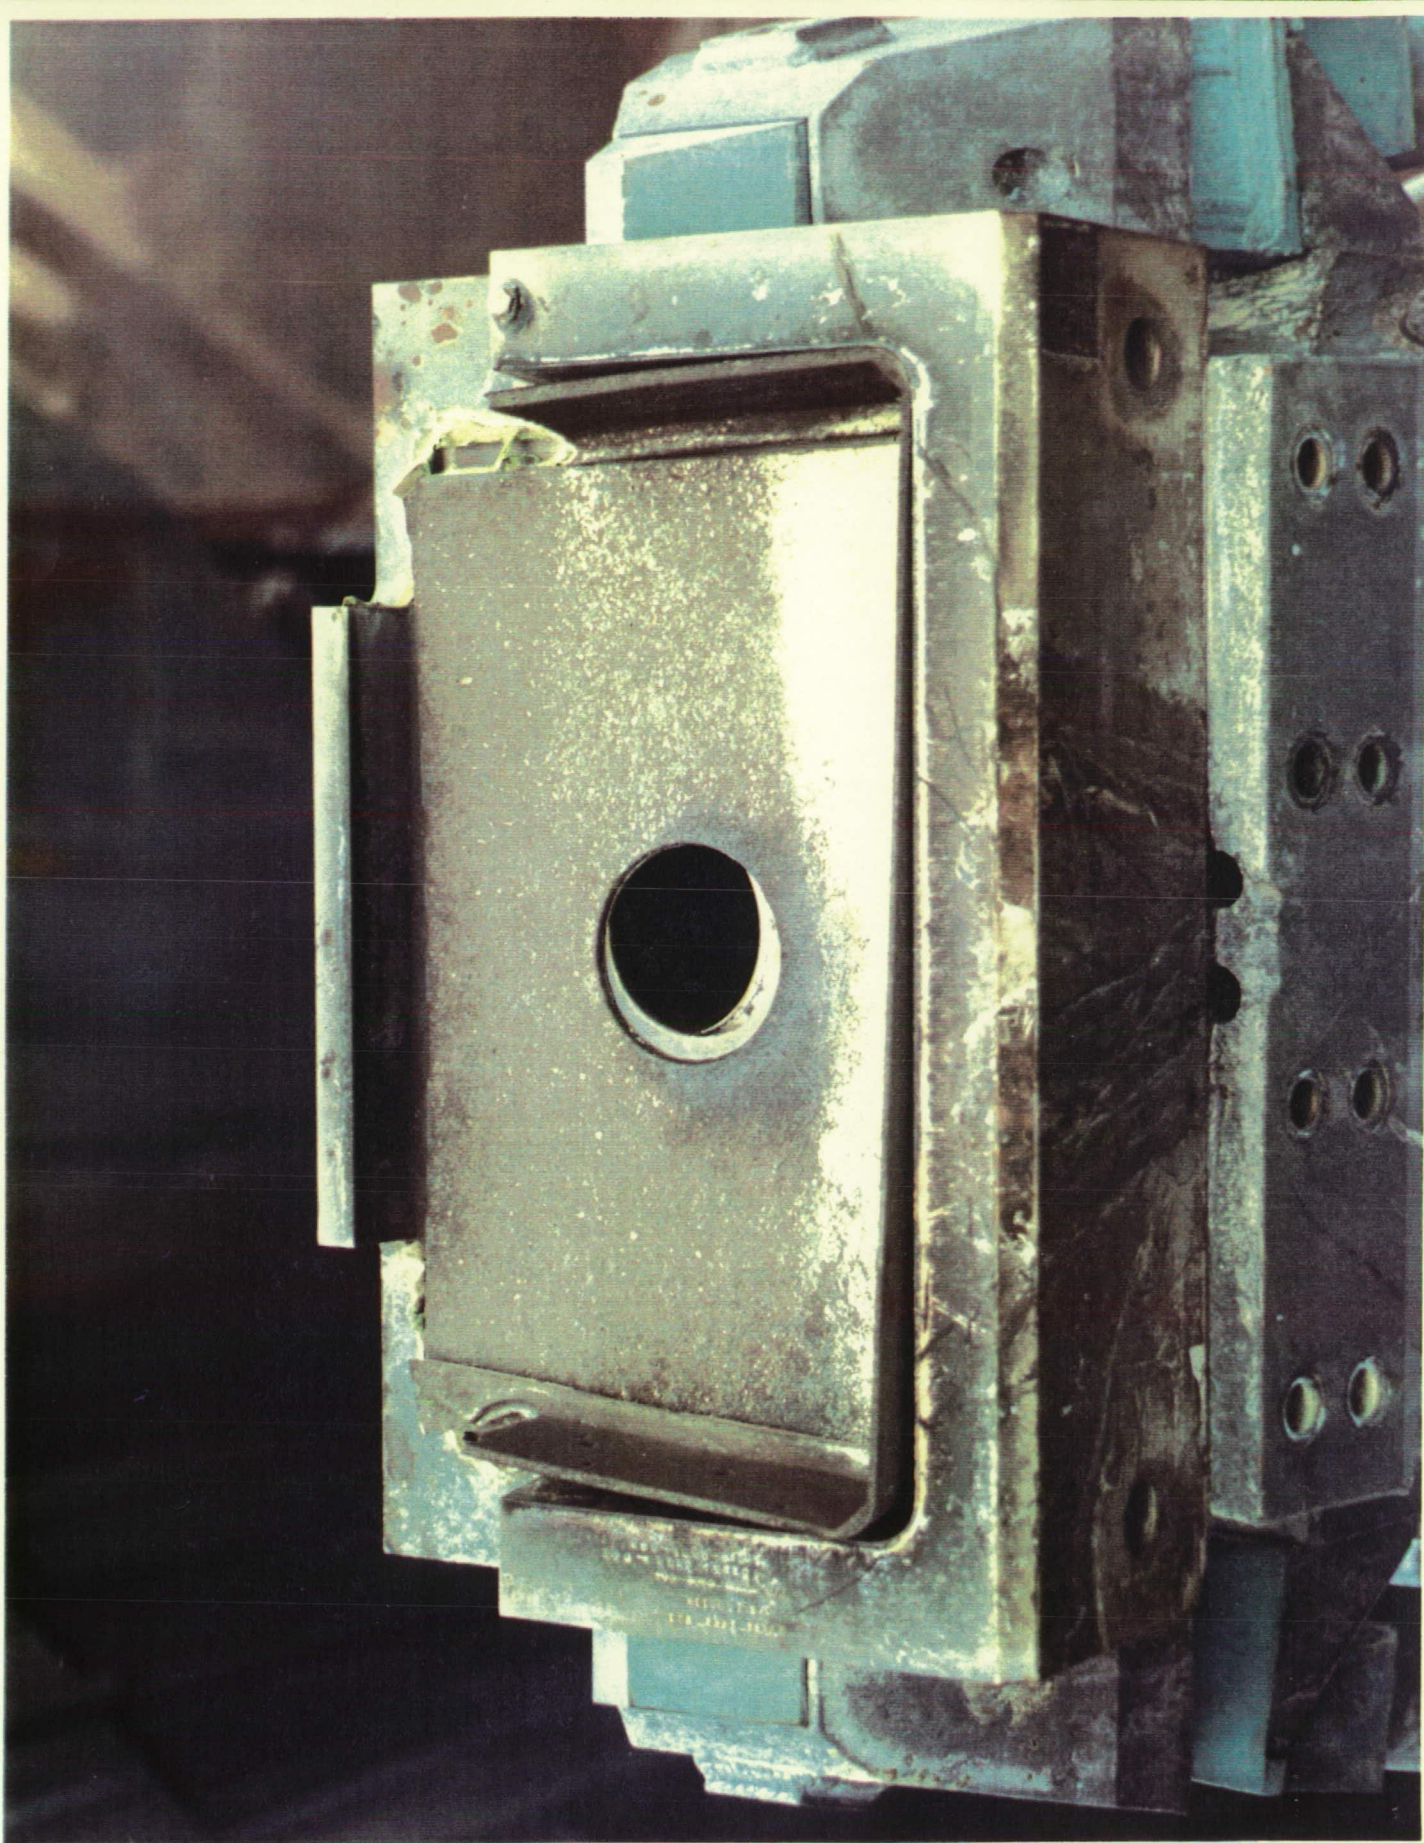
HDP #1 Epon shim material was 100 percent debonded

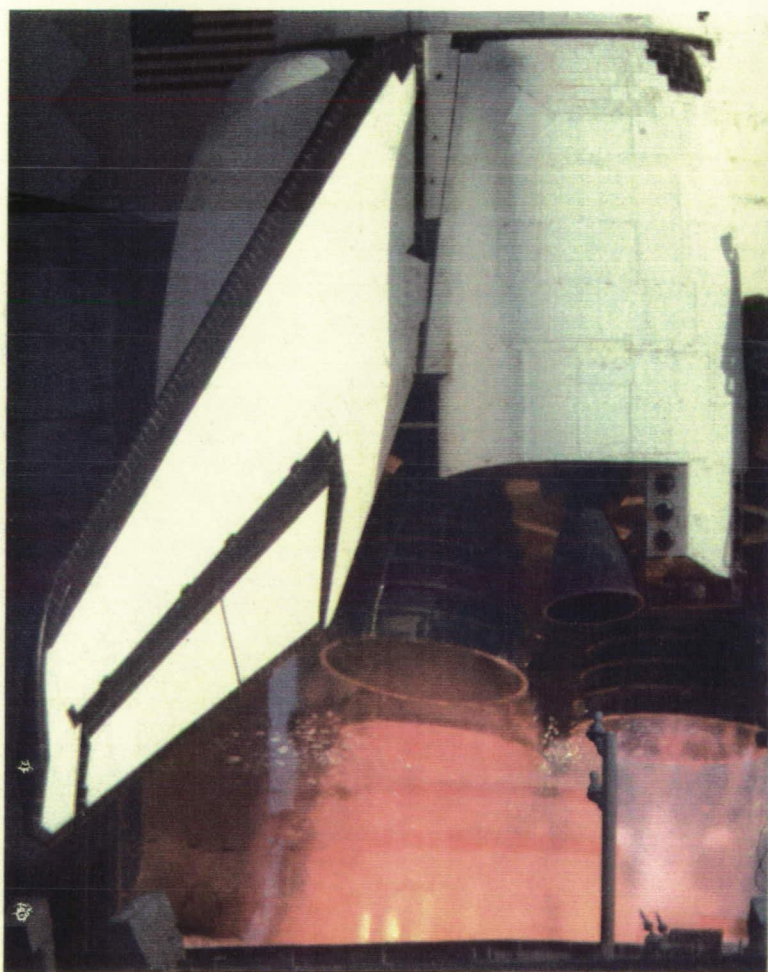
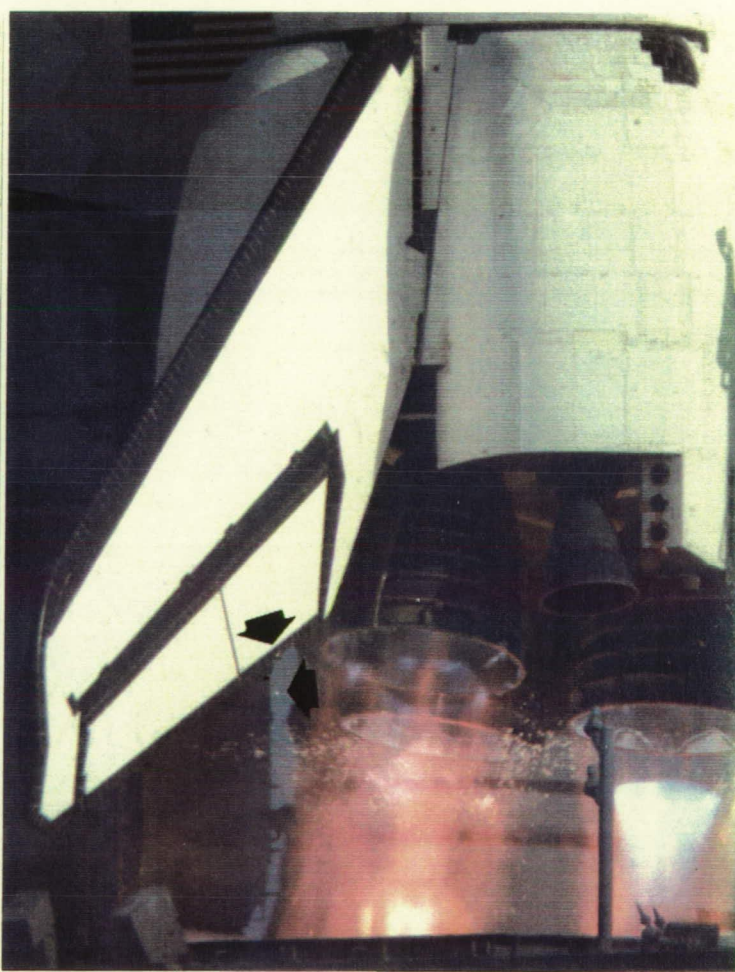
Before/after view of rudder speed brake as SSME ignition
acoustics/vibration cause a 2-1/2" chip in a tile (E-76)

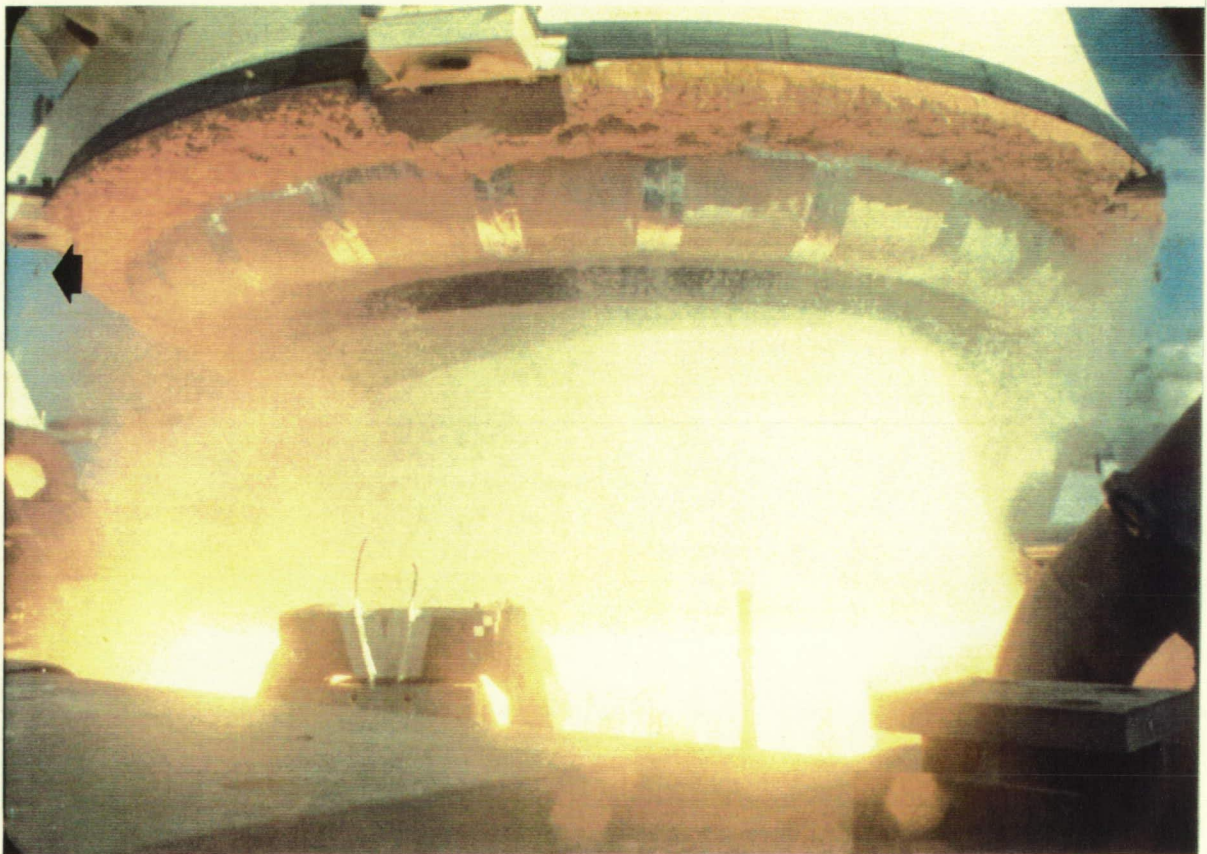
An ordnance debris fragment falls from the RH SRB HDP #1
stud hole shortly after liftoff (E-8)

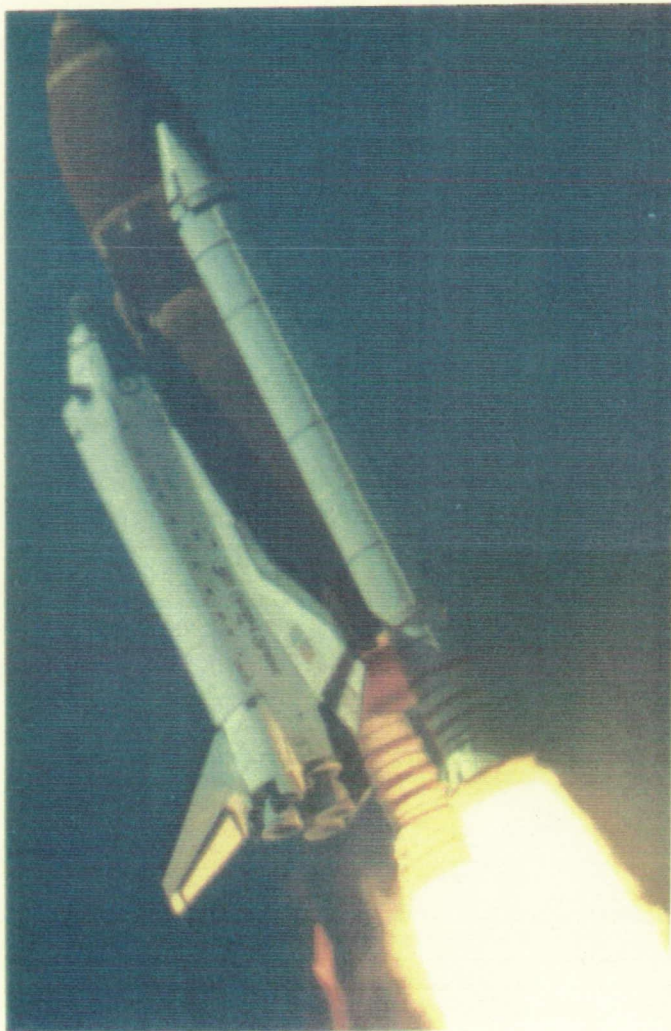
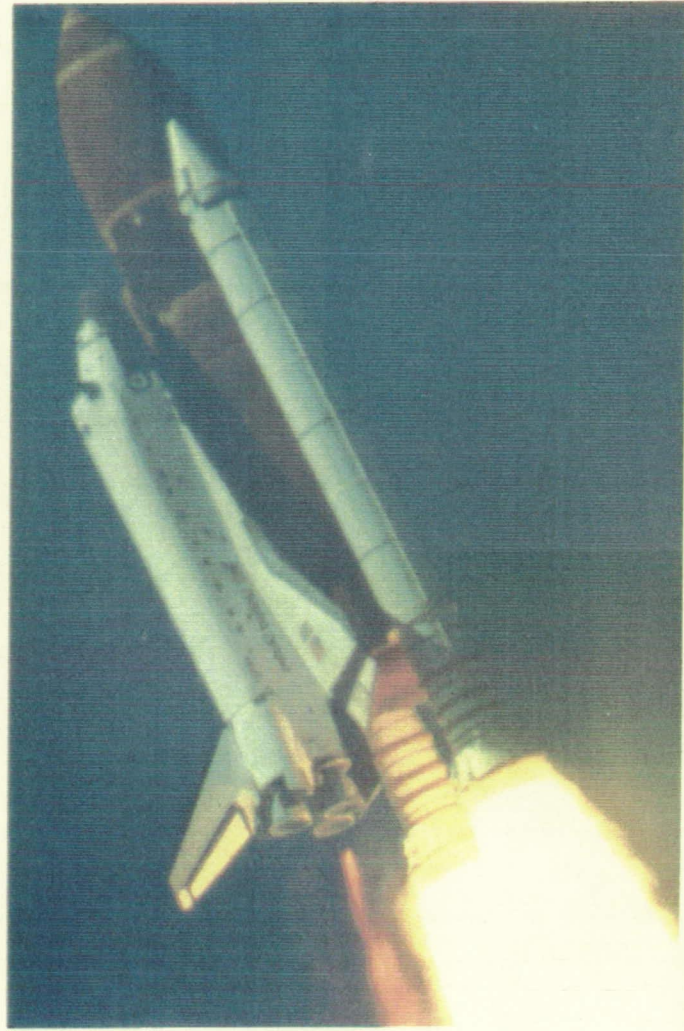
Orange flashes continue to occur in the SSME plumes during ascent (E-212) and may be caused by debris

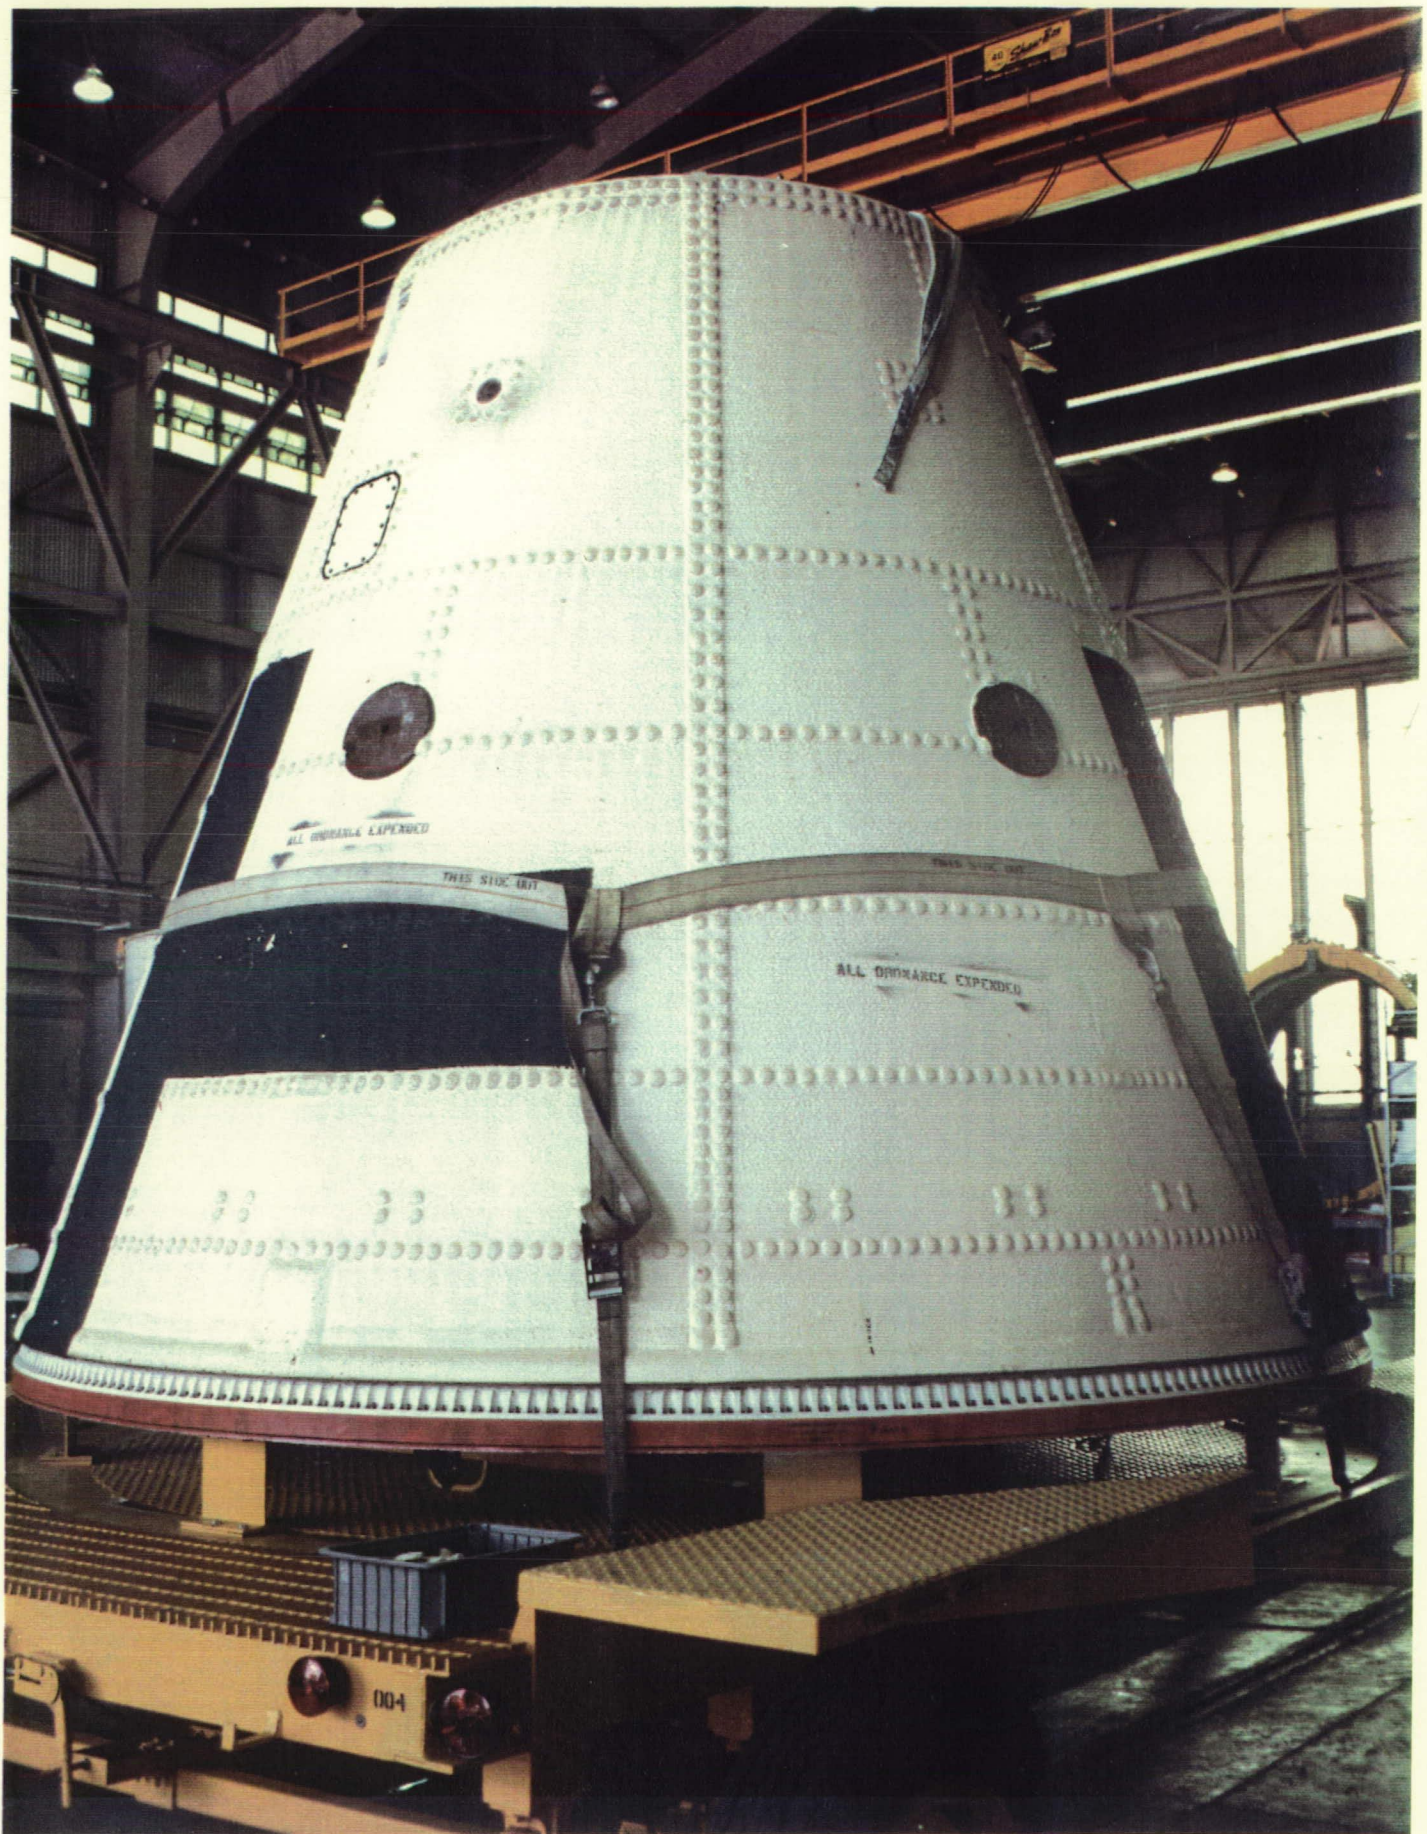
Post flight condition of RH frustum. There were 5 debonds over fasteners, but no areas of missing TPS.

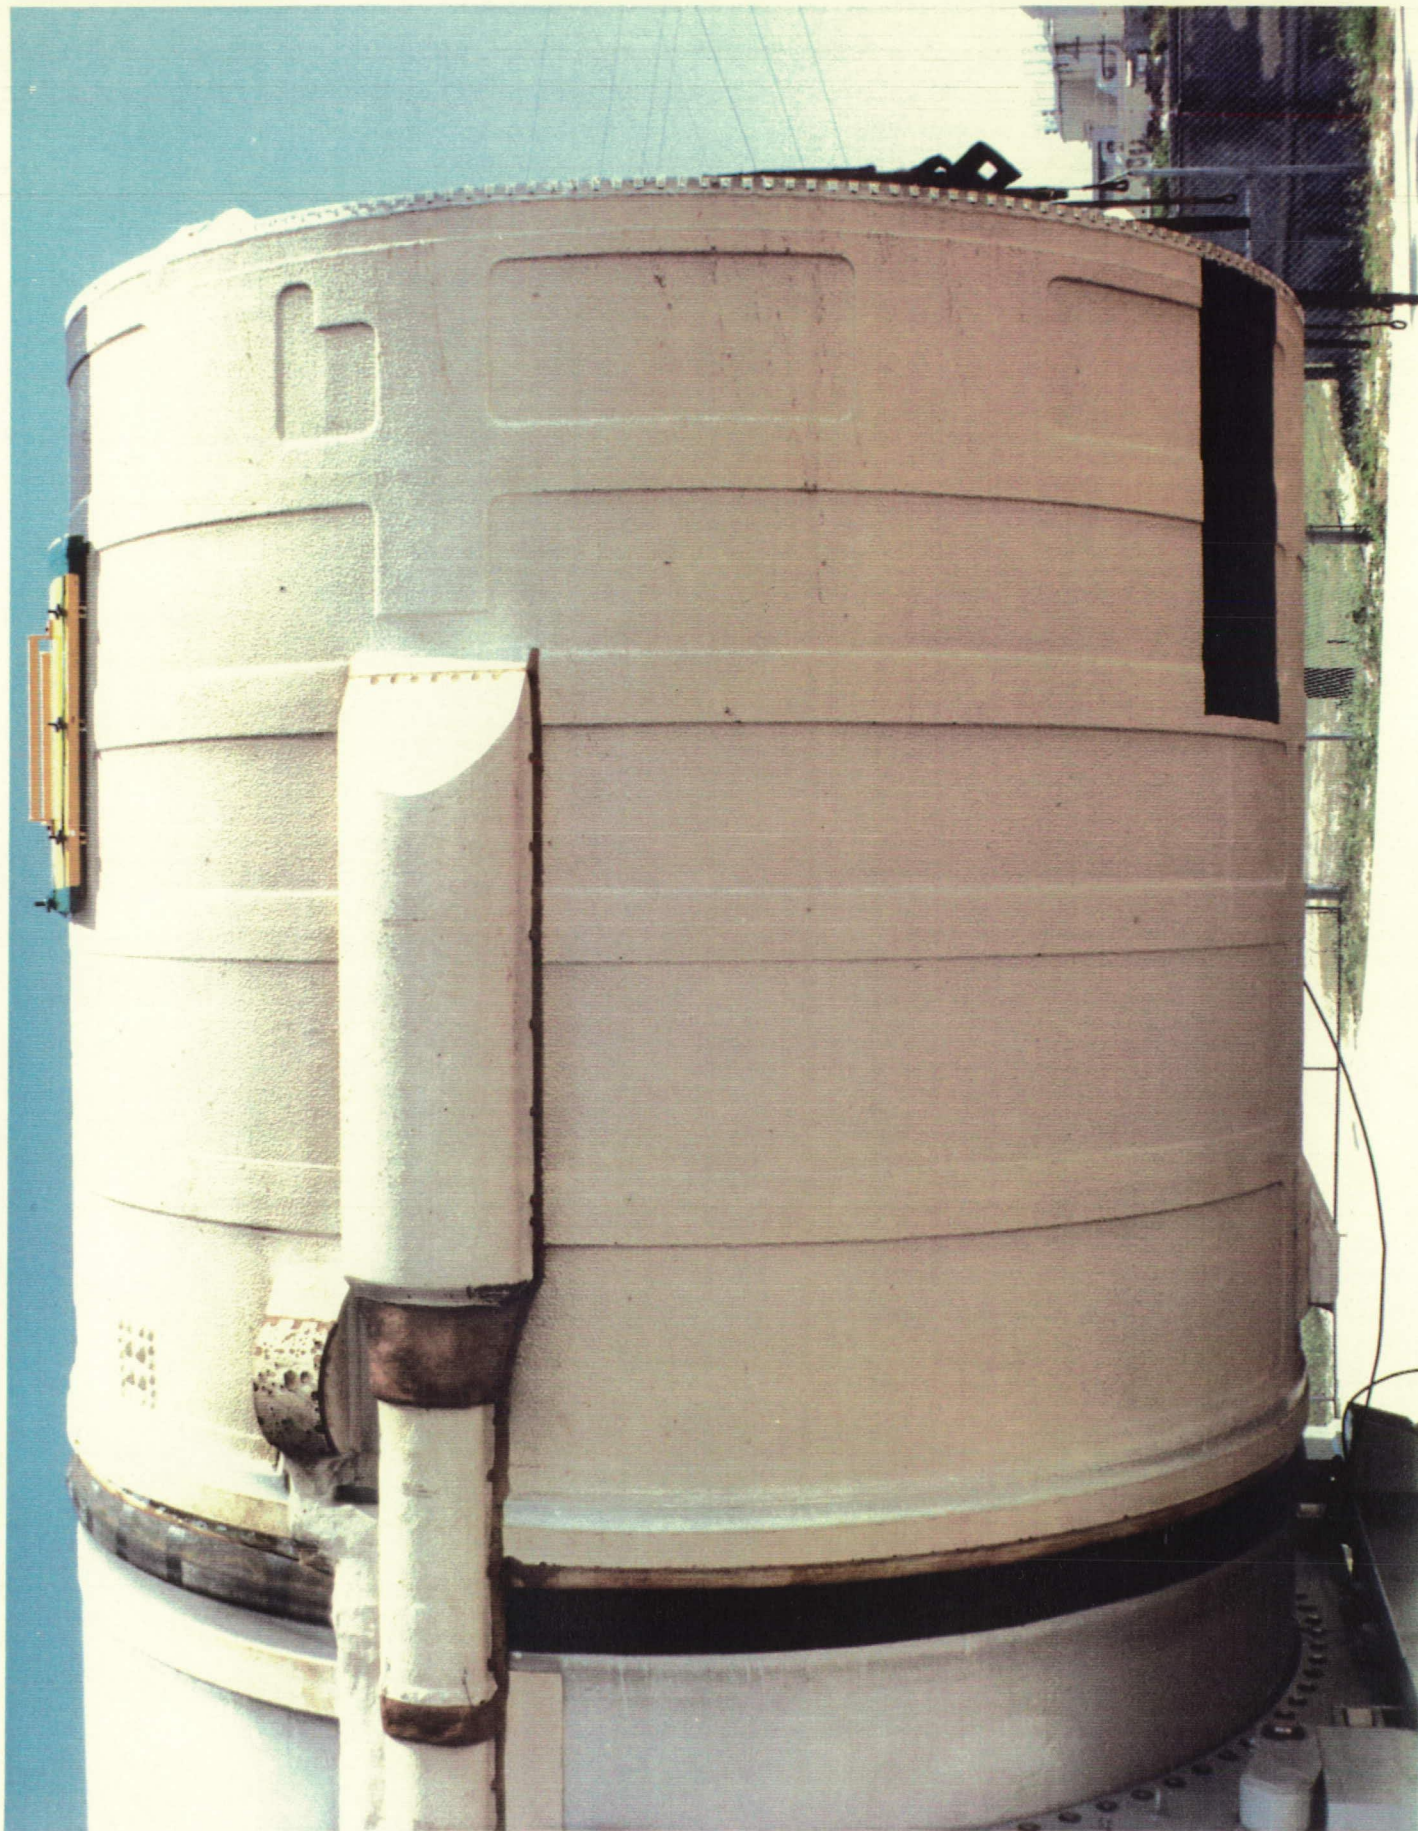
Post flight condition of RH forward skirt. There were no debonds or areas of missing TPS

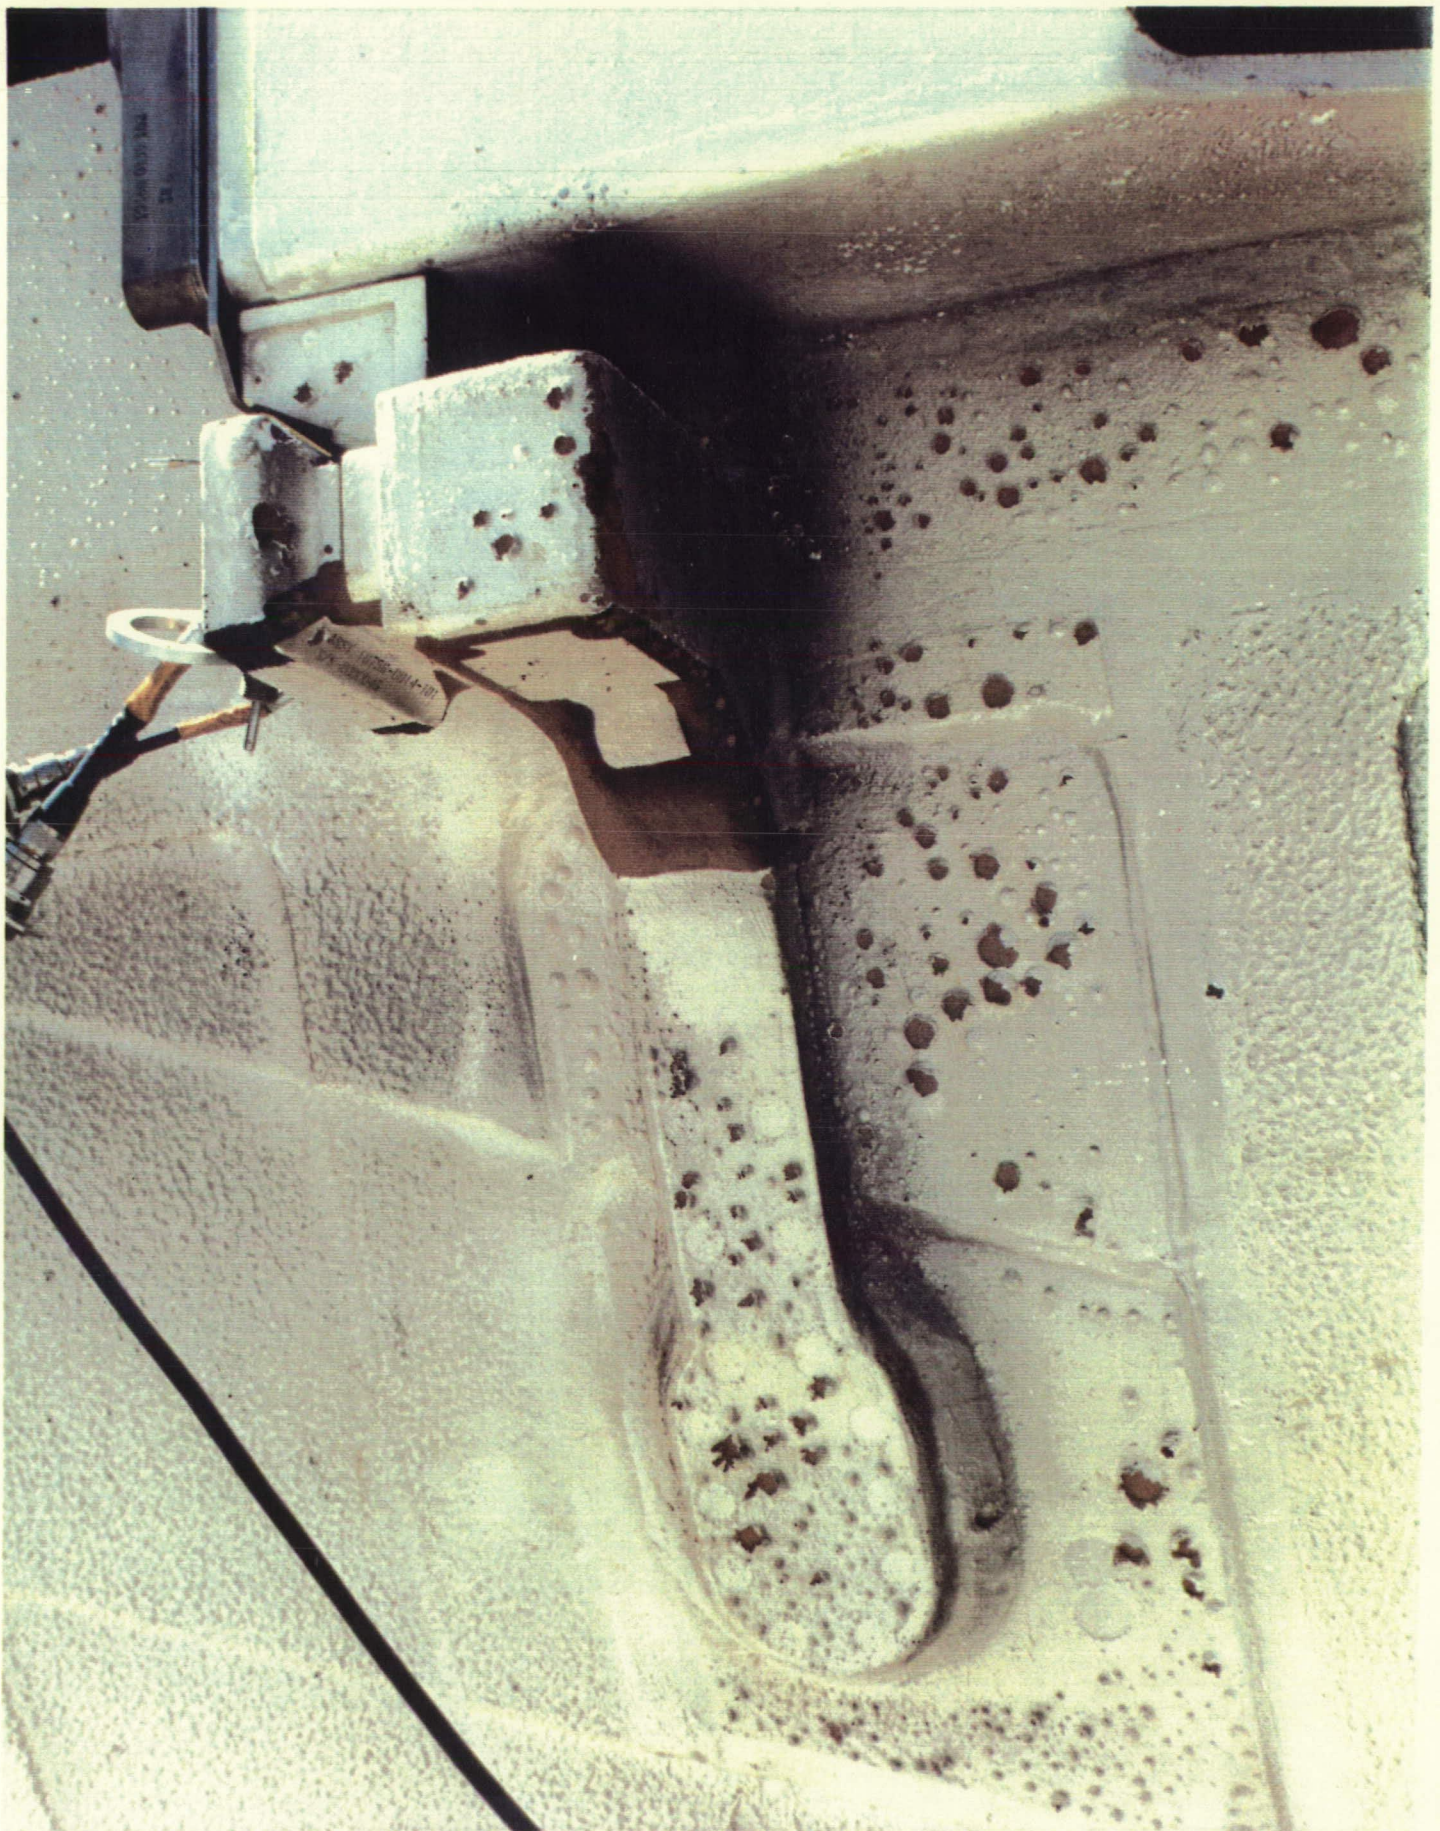
Localized areas of Hypalon paint blistered with some layers of
MSA-2 adhering to the paint
